Technical Report CERC-95-9
July 1995

Monitoring of the Yaquina Bay Entrance North Jetty at Newport, Oregon; Summary and Results

by Steven A. Hughes, Terri L. Prickett,
Michael W. Tubman, William D. Corson

Final report

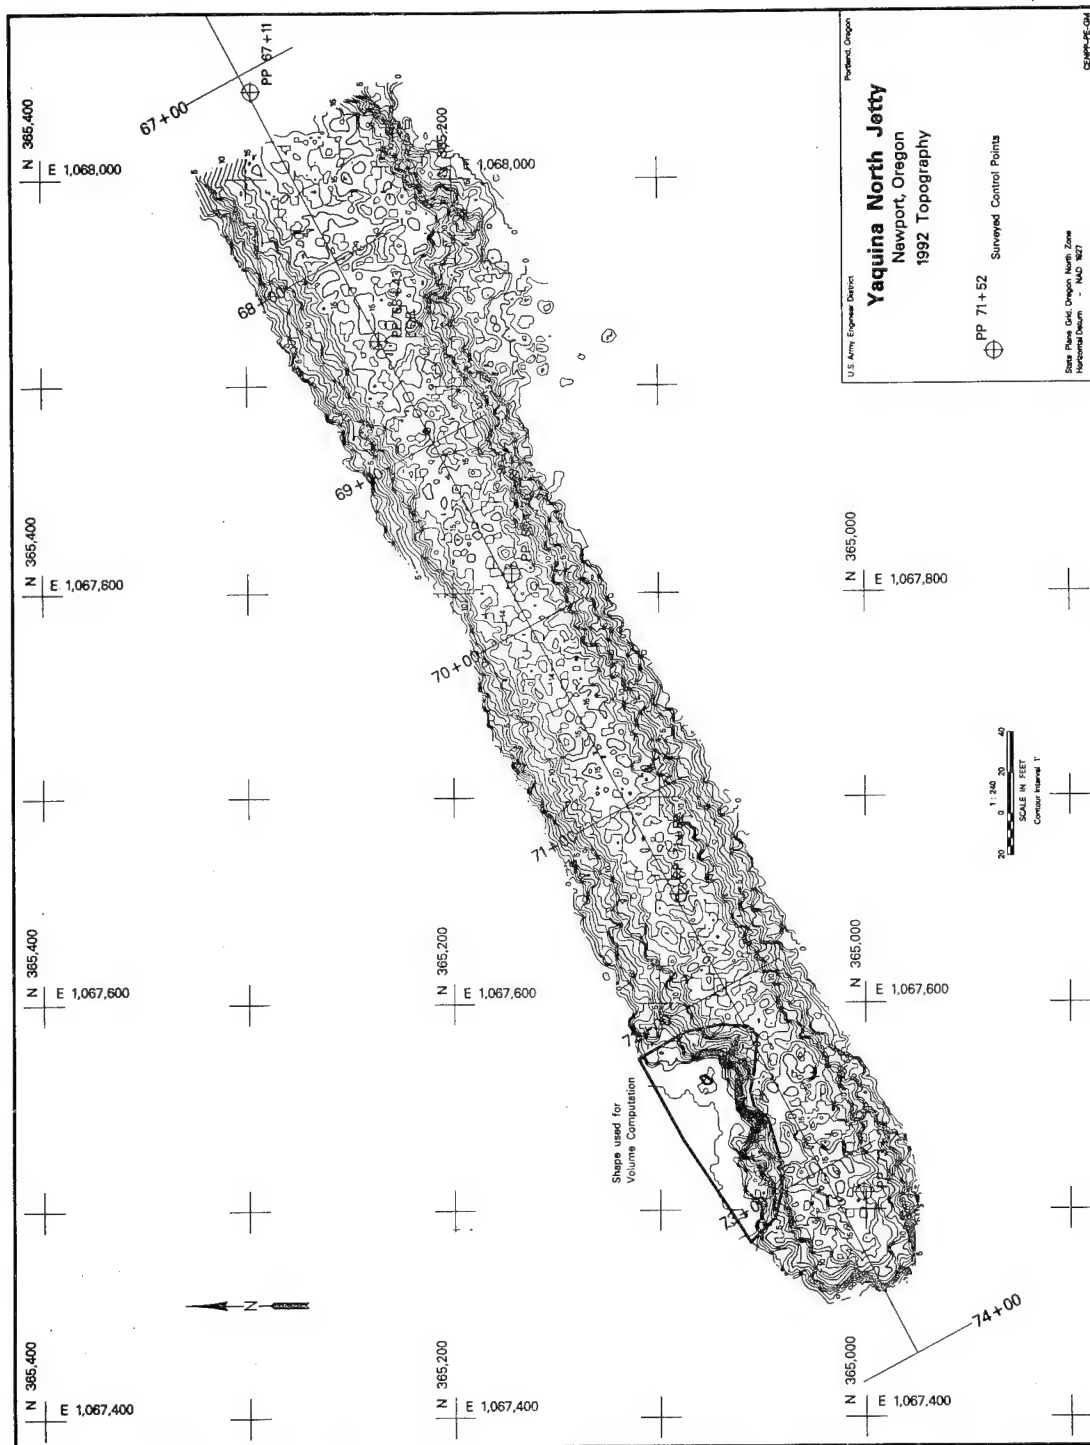
Analysis of each photogrammetry overflight produced a contour map of the jetty showing elevation contours at 30-cm (1-ft) vertical intervals for that region of the structure visible above the tide level. Figures 40 and 41 show the above-water north jetty elevation contours determined from the February 1992 and the May 1993 overflights. Particularly noticeable is the steep face of the "notch" area clearly visible near the jetty tip. The stereo model data can also be used to create three-dimensional "mesh" drawings of the jetty as shown in Figure 42 for the 1993 helicopter photogrammetric analysis.

Figure 40. Yaquina Bay north jetty 1992 topography

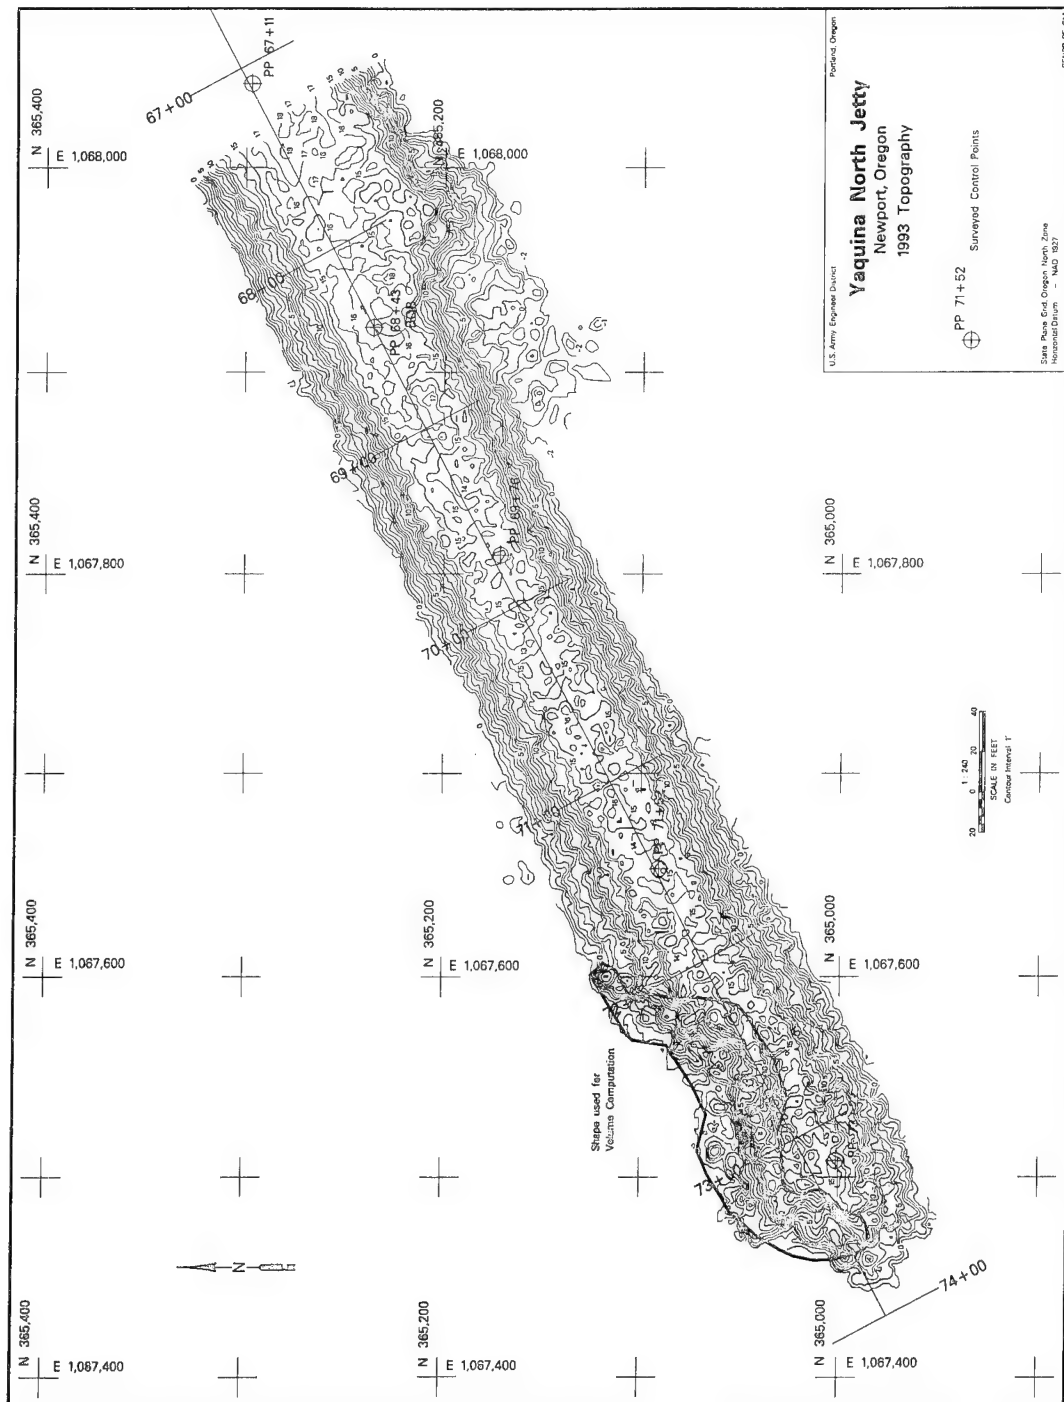
Figure 41. Yaquina Bay north jetty 1993 topography

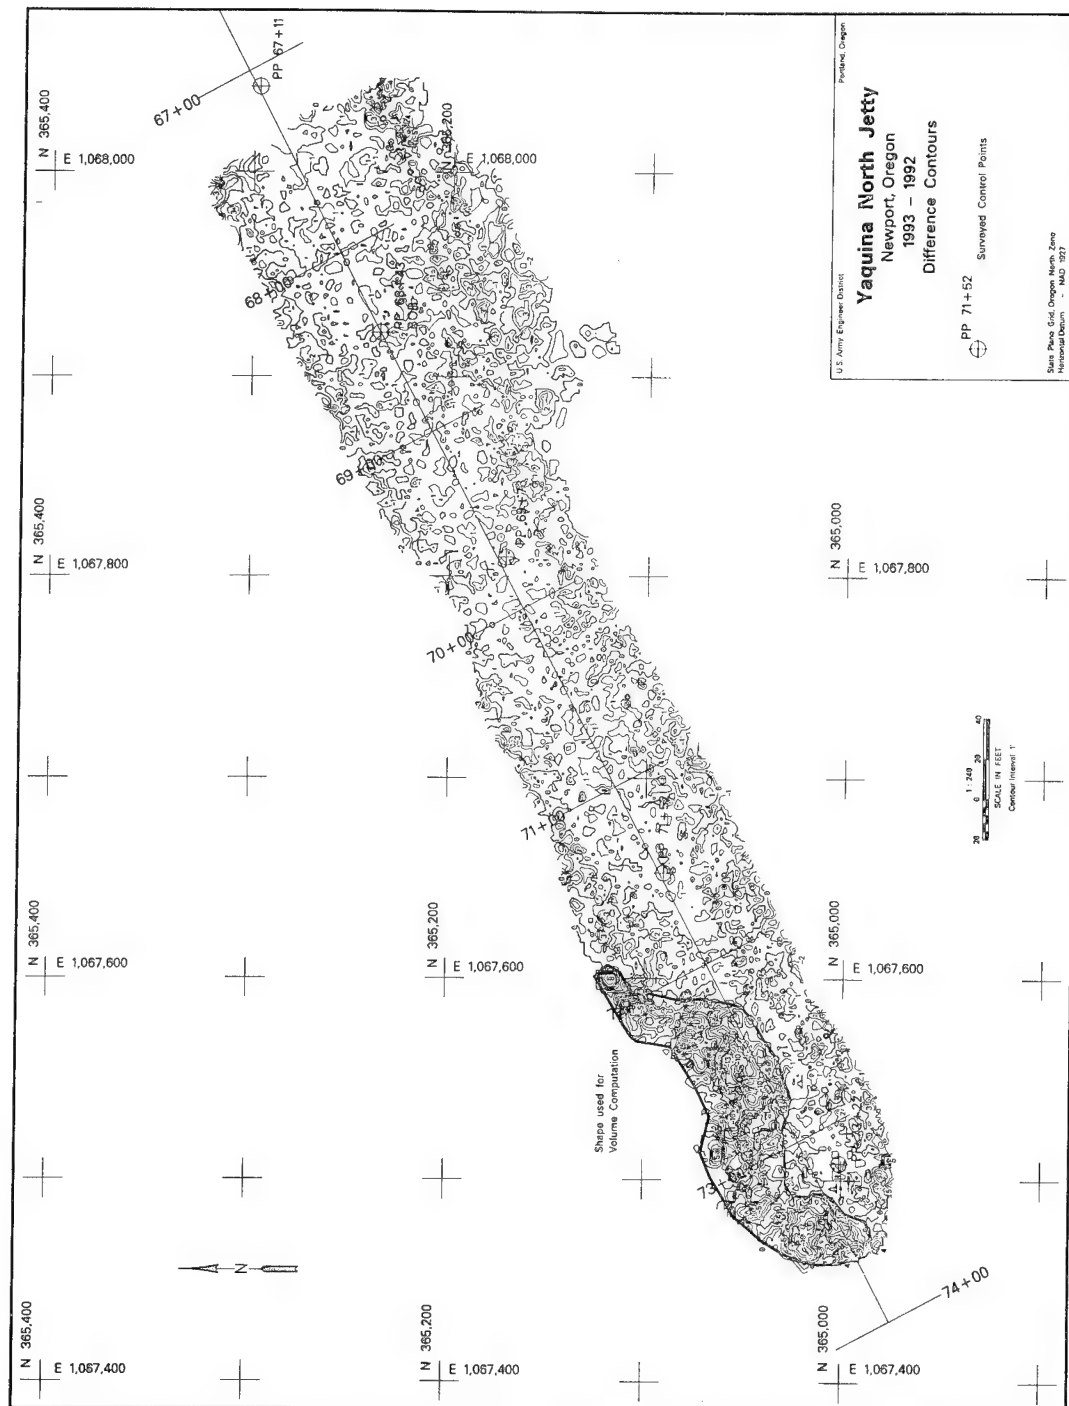
As mentioned, gridded elevations from different dates can be combined to produce difference contours. Figure 43 shows the difference contours found between stereo models for the 1992 and 1993 overflights. This figure is included only to give an impression of the product. The original products

Figure 43. Difference between 1992 and 1993 north jetty contours

have different colored contours to denote positive and negative differences, and they are far more informative than what is shown in black and white on Figure 43.

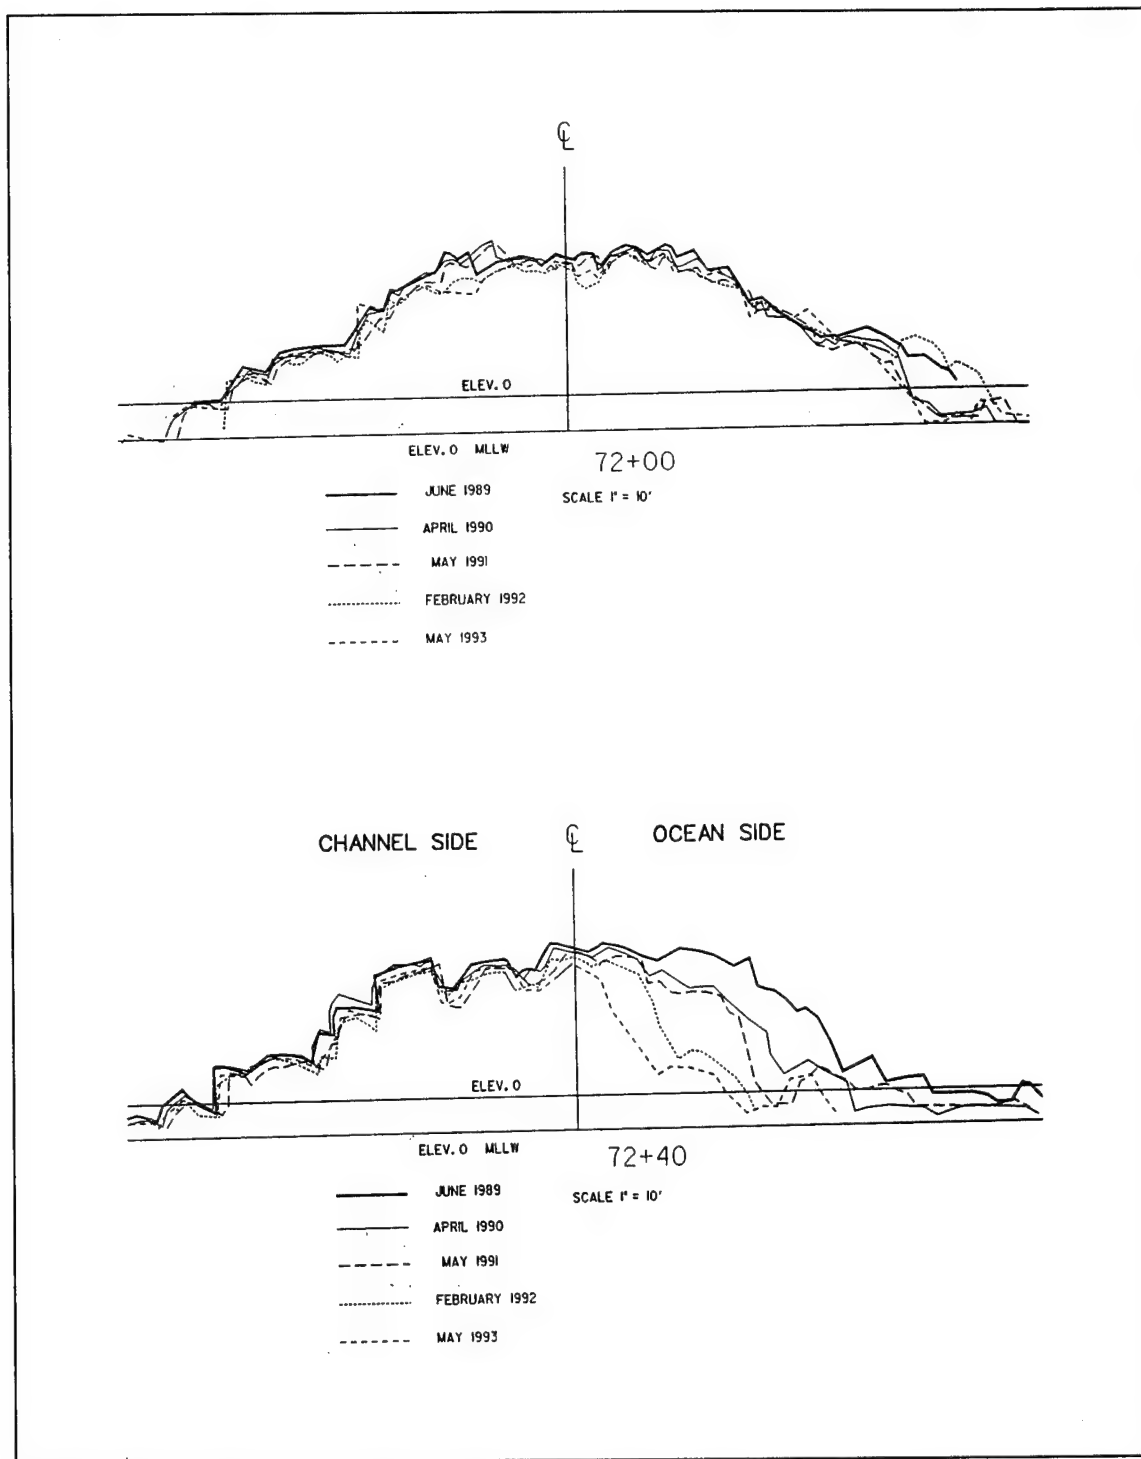
- c. The most profile change occurred in the vicinity of the "notch" (Figure 45, range 72+40). Significant damage occurred between the years 1989 - 1991. This was followed by a year when the only armor stone losses in the notch area occurred on the landward side of the notch. However, between the 1992 and 1993 overflights, massive profile losses occurred in the notch area to the extent that stones were lost over much of the structure's crest (see range 72+70, Figure 46).

Figure 45. Stereo model jetty profile comparisons, ranges 72+00 and 72+40

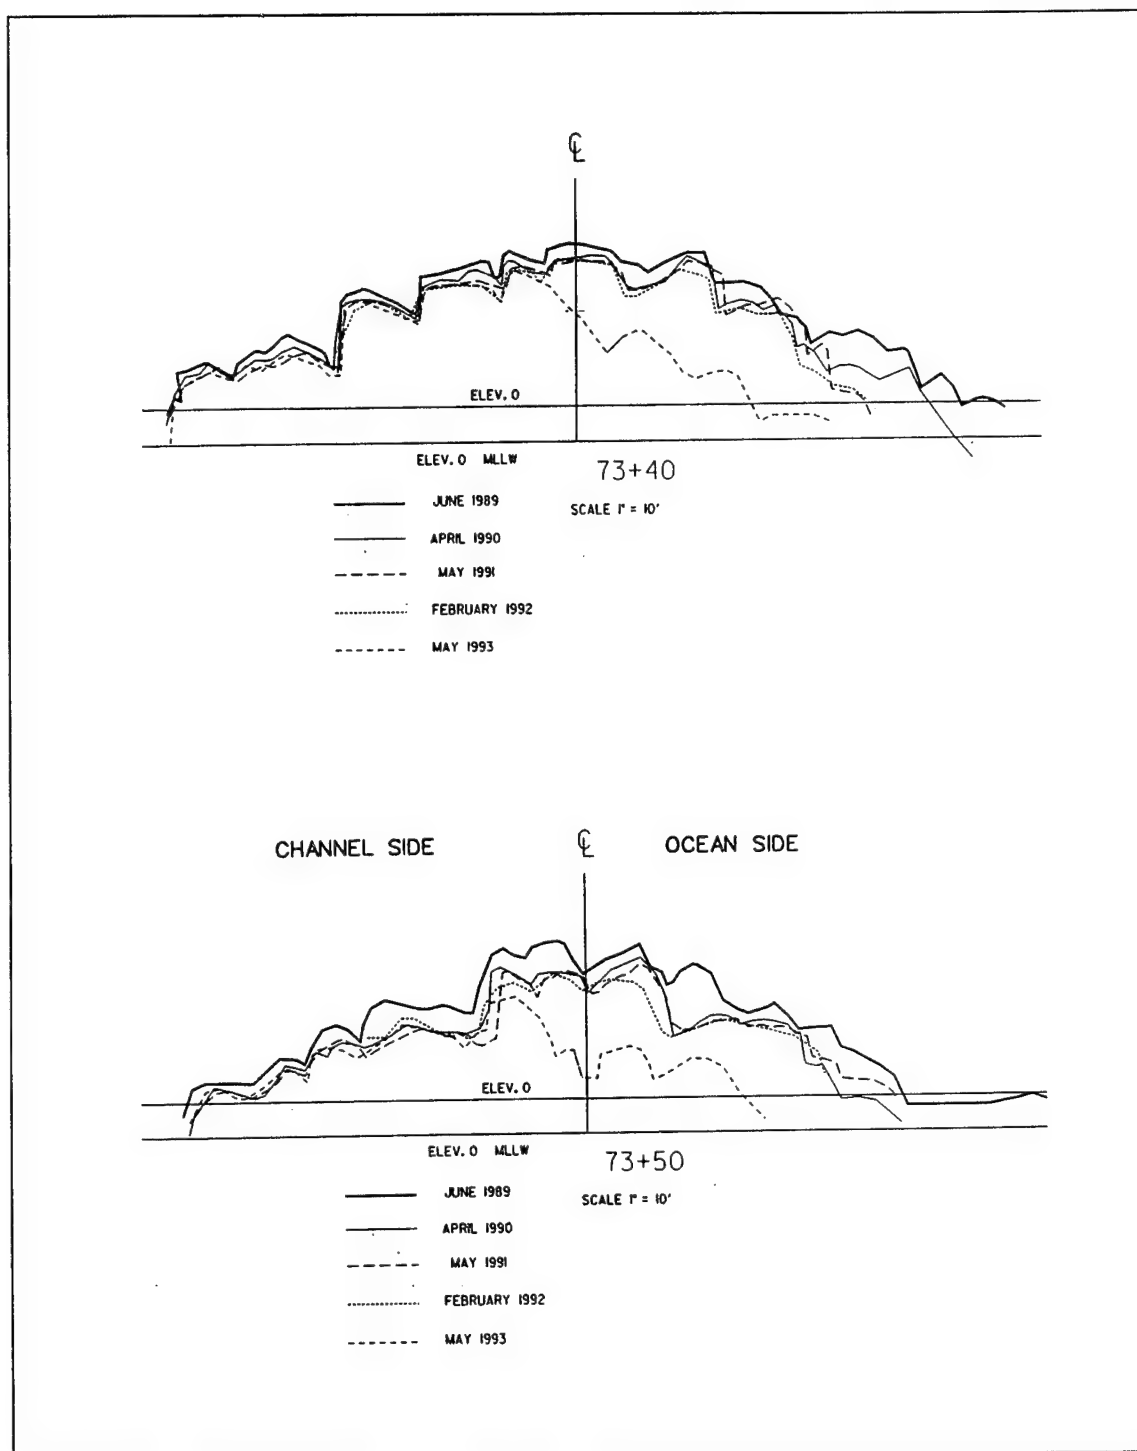
- b. The structure appears to have undergone some initial vertical settlement on the order of 1-2 m (3-6 ft) out near the tip as "nesting" occurred during the first 2 years after construction. This settlement was expected, and questions about inaccuracies in the analyses near the jetty tip were answered by subsequent results in the years 1990 - 1992, which show a relatively stable profile (see range 73+50, Figure 47). Winter storms between 1992 and 1993 substantially eroded the jetty tip. This was the first damage noted on the extreme tip during the monitoring period.

Figure 47. Stereo-model jetty profile comparisons, ranges 73+40 and 73+50

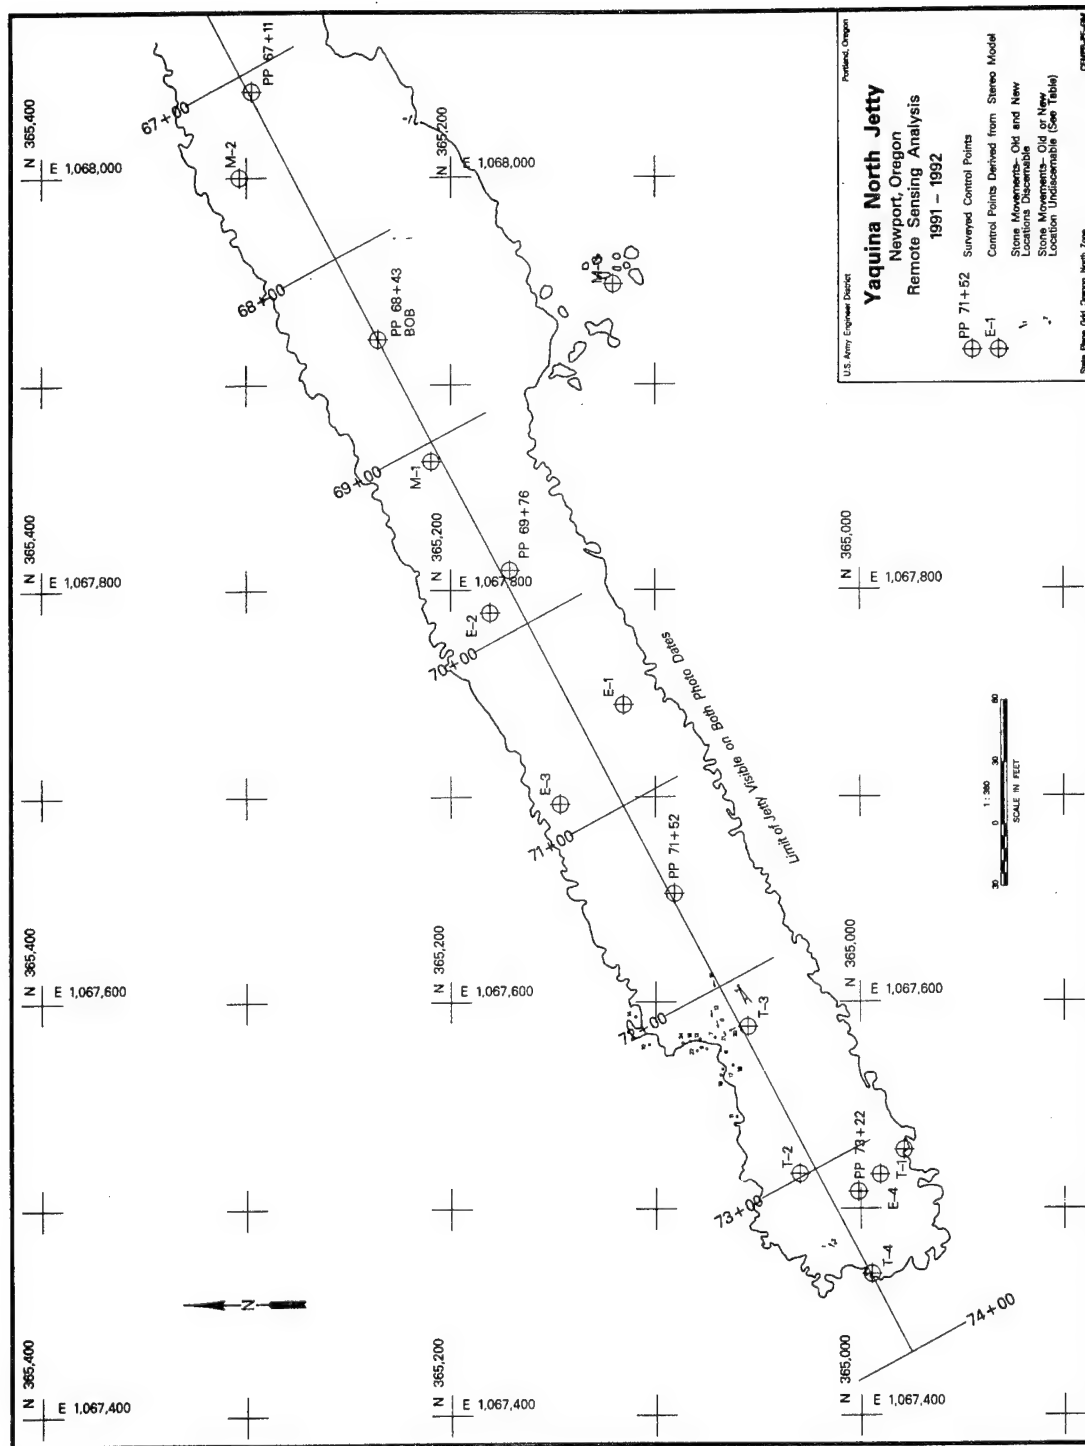
Between the 1989 and 1990 photographs there was a significant amount of stone movement detected in the vicinity of the "notch" as the structure made its initial adjustment to the environmental conditions. The comparison between 1990 and 1991 showed little movement of stone in the notch area, with only four armor stones disappearing and three stones moving distances ranging between 1 and 3 m (3 and 10 ft).

Figure 48. Individual armor stone movements between 1991 and 1992

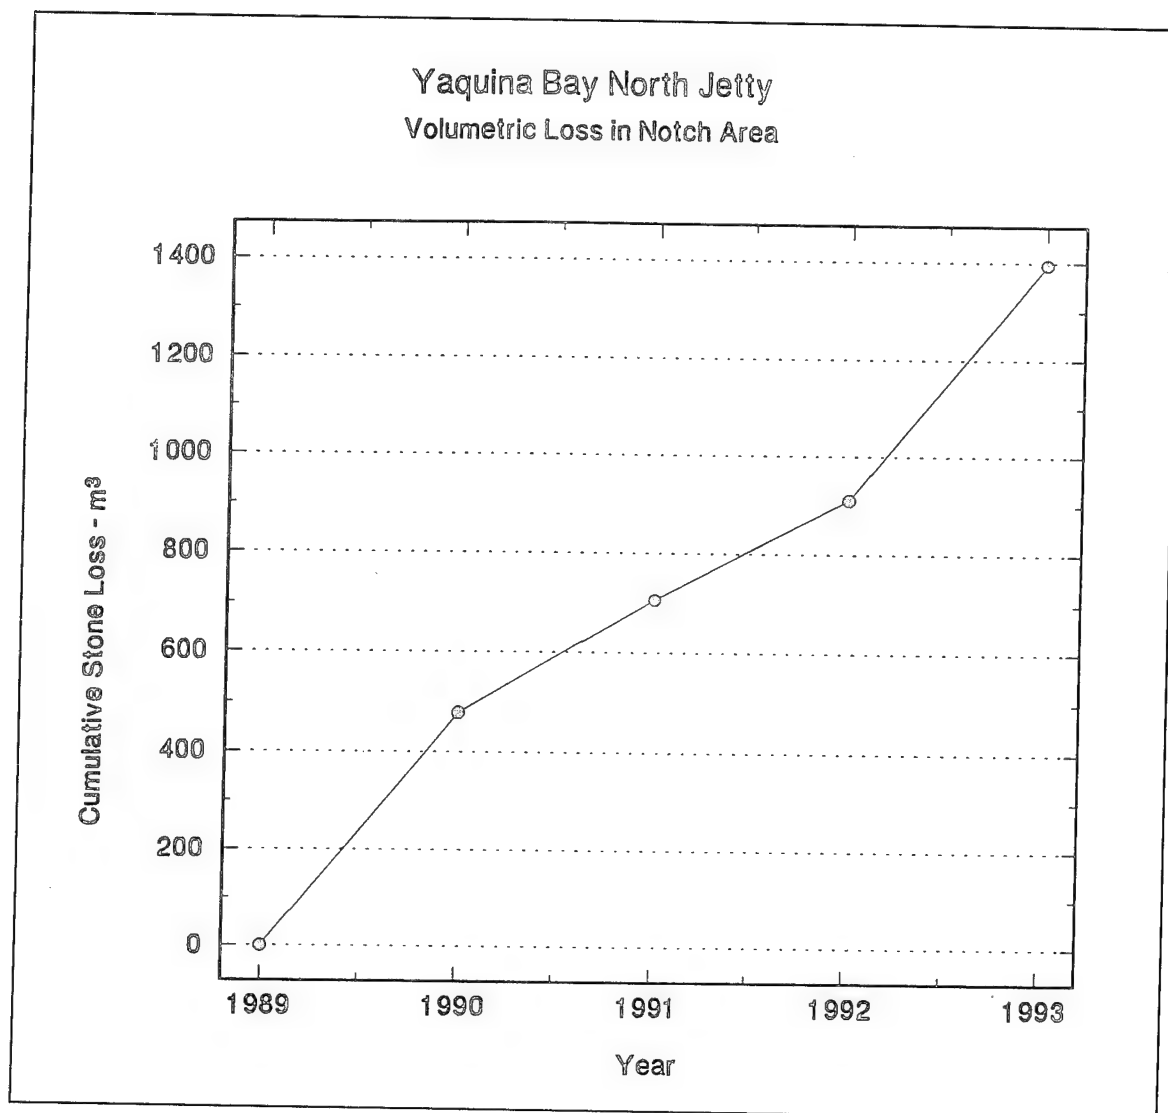
Figure 52. Volumetric change in the "notch" area between 1989 and 1993

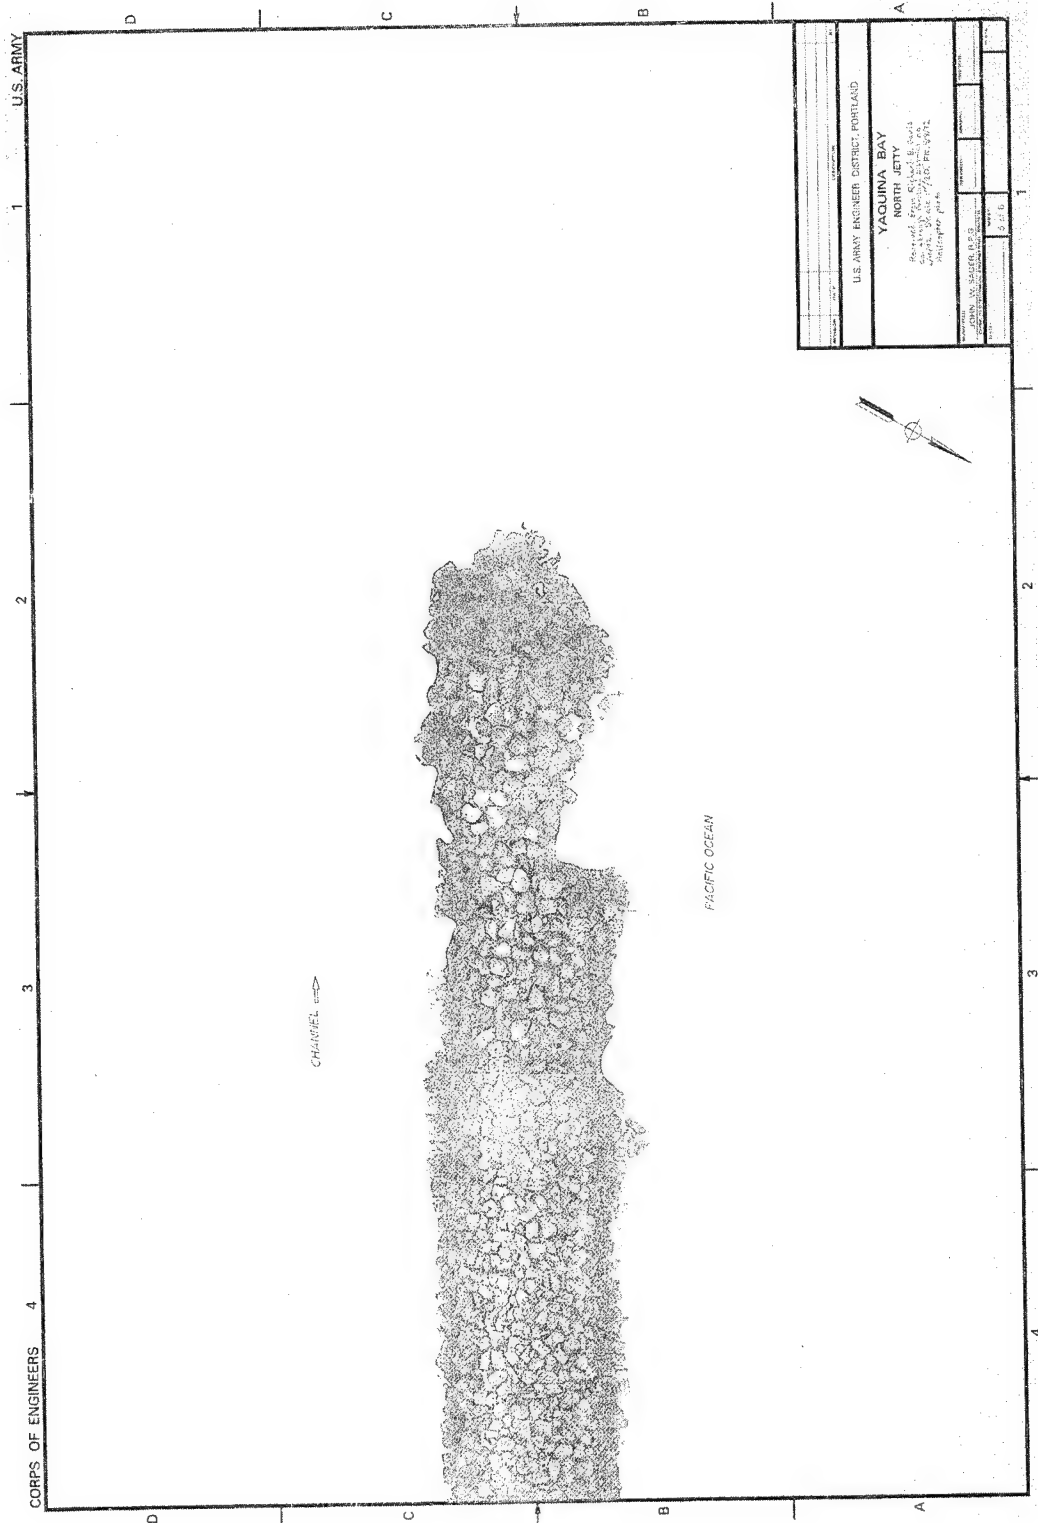
Figure 54. Helicopter photograph of Yaquina Bay north jetty tip, 1992

Figure 54 shows a composite photograph of the seaward tip of the north jetty acquired during the 1992 helicopter overflight. Figure 55 shows the contours developed from the photogrammetry, similar to the fixed-wing

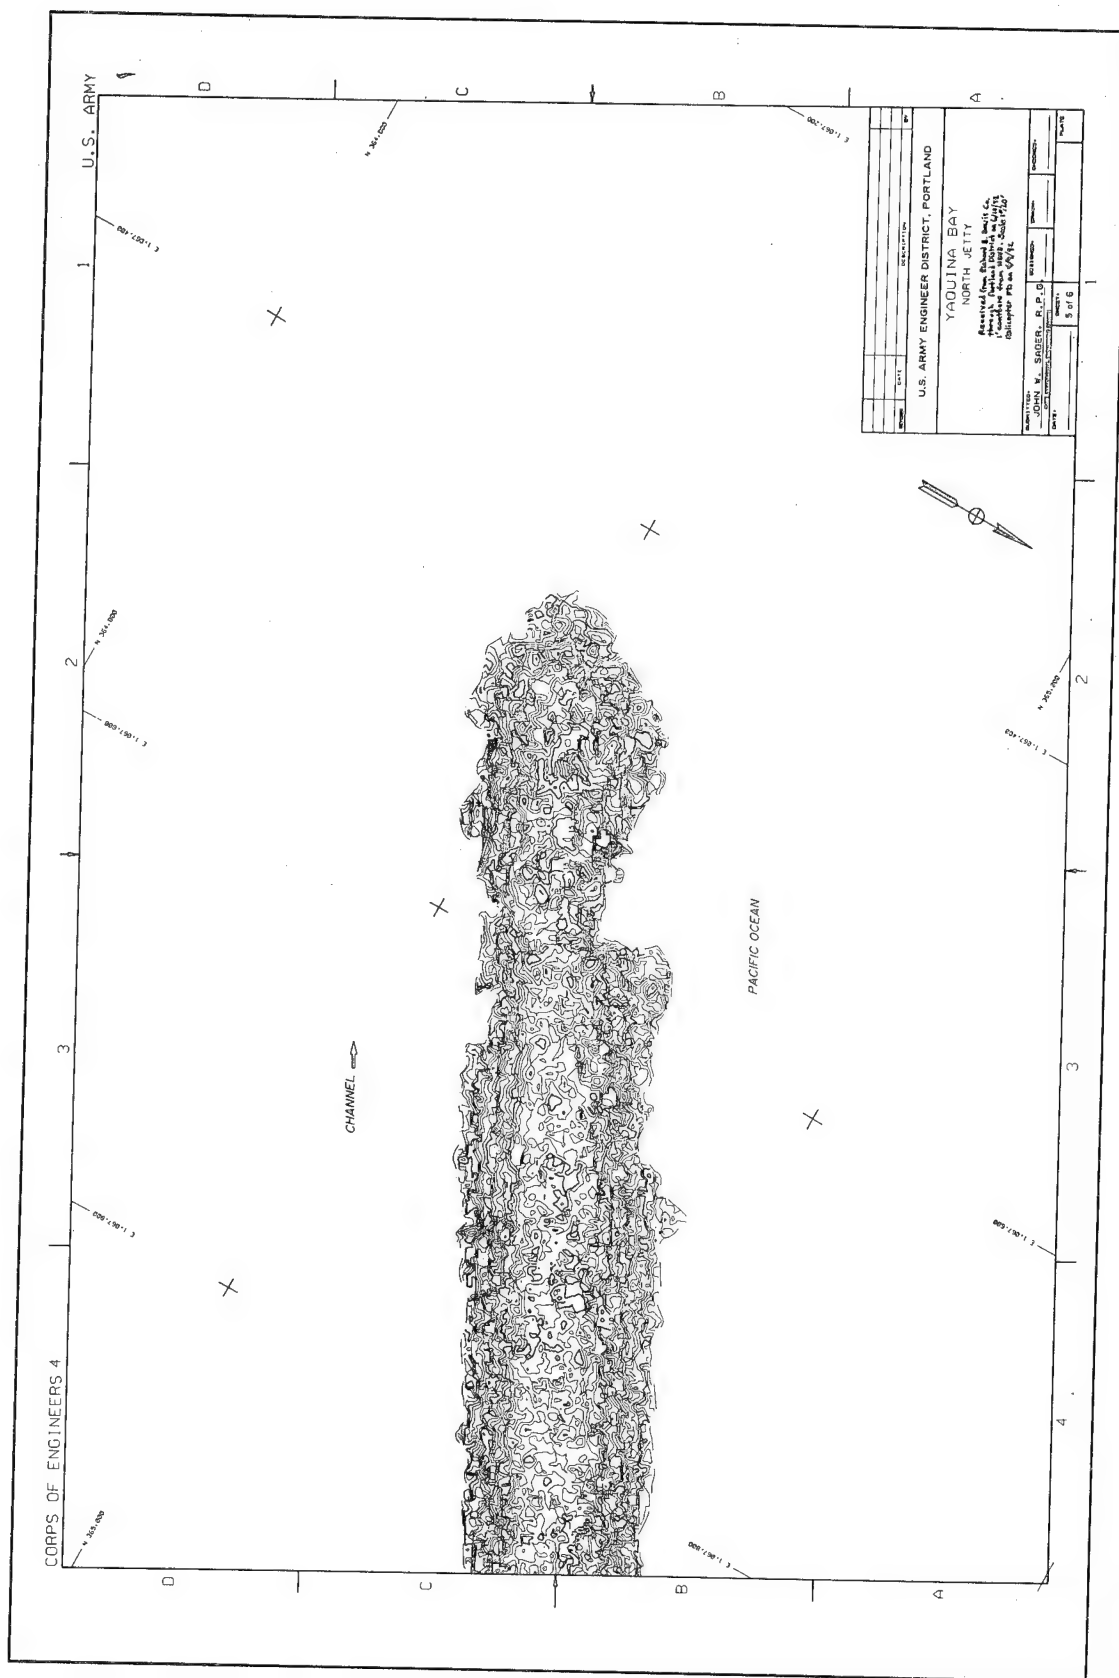
Figure 55. Elevation contours from the 1992 helicopter overflight

photogrammetry shown in Figure 40. A "mesh" orthographic projection of the jetty also was plotted from the stereo model, as shown in Figure 56.

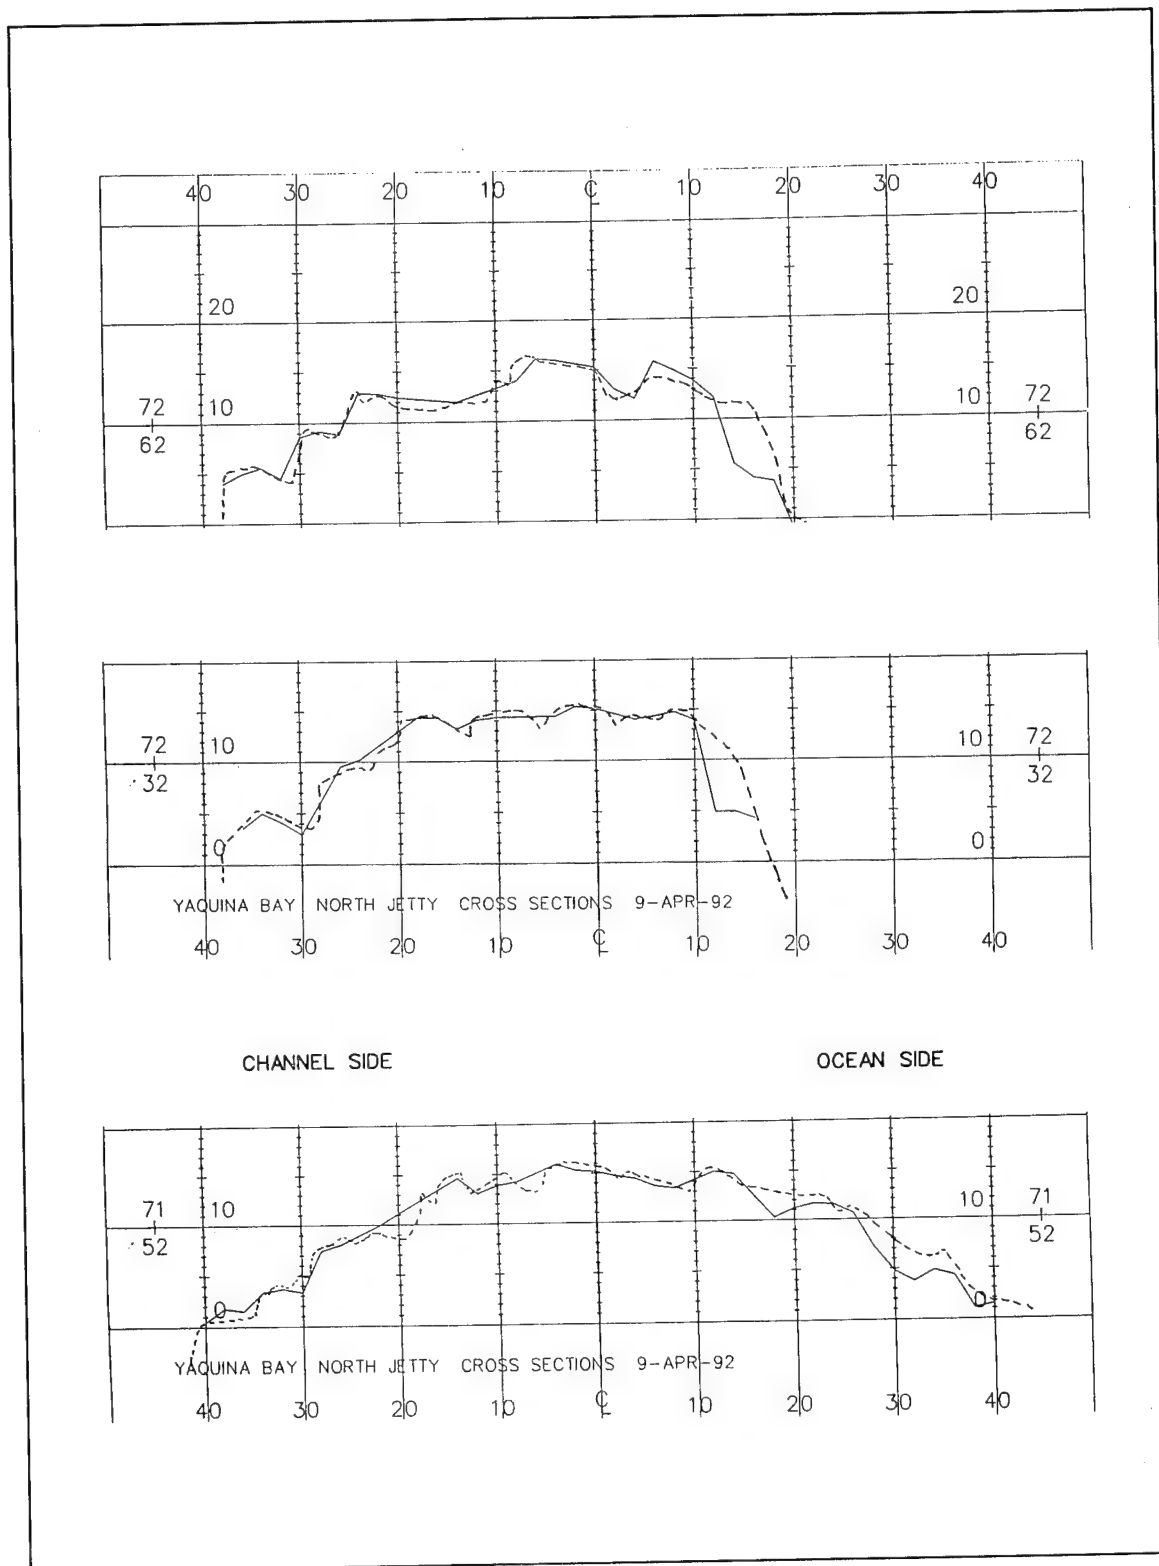
Figure 57. Comparison between 1992 helicopter (solid line) and fixed-wing (dashed line) cross sections

Figure 57 compares three of the 1992 helicopter cross sections (solid line) to the respective fixed-wing cross section (dashed line) that were obtained about 6 weeks earlier. For this limited comparison, reasonable agreement is observed overall, but isolated differences in elevation up to about 3 m (10 ft) are noted. This may be due to misalignment of the coordinate systems used in the two stereo models or interpretation of the stereo photographs. Whichever the case, it is not possible to state absolutely which profiles are correct without further ground-truth from land-based surveys.

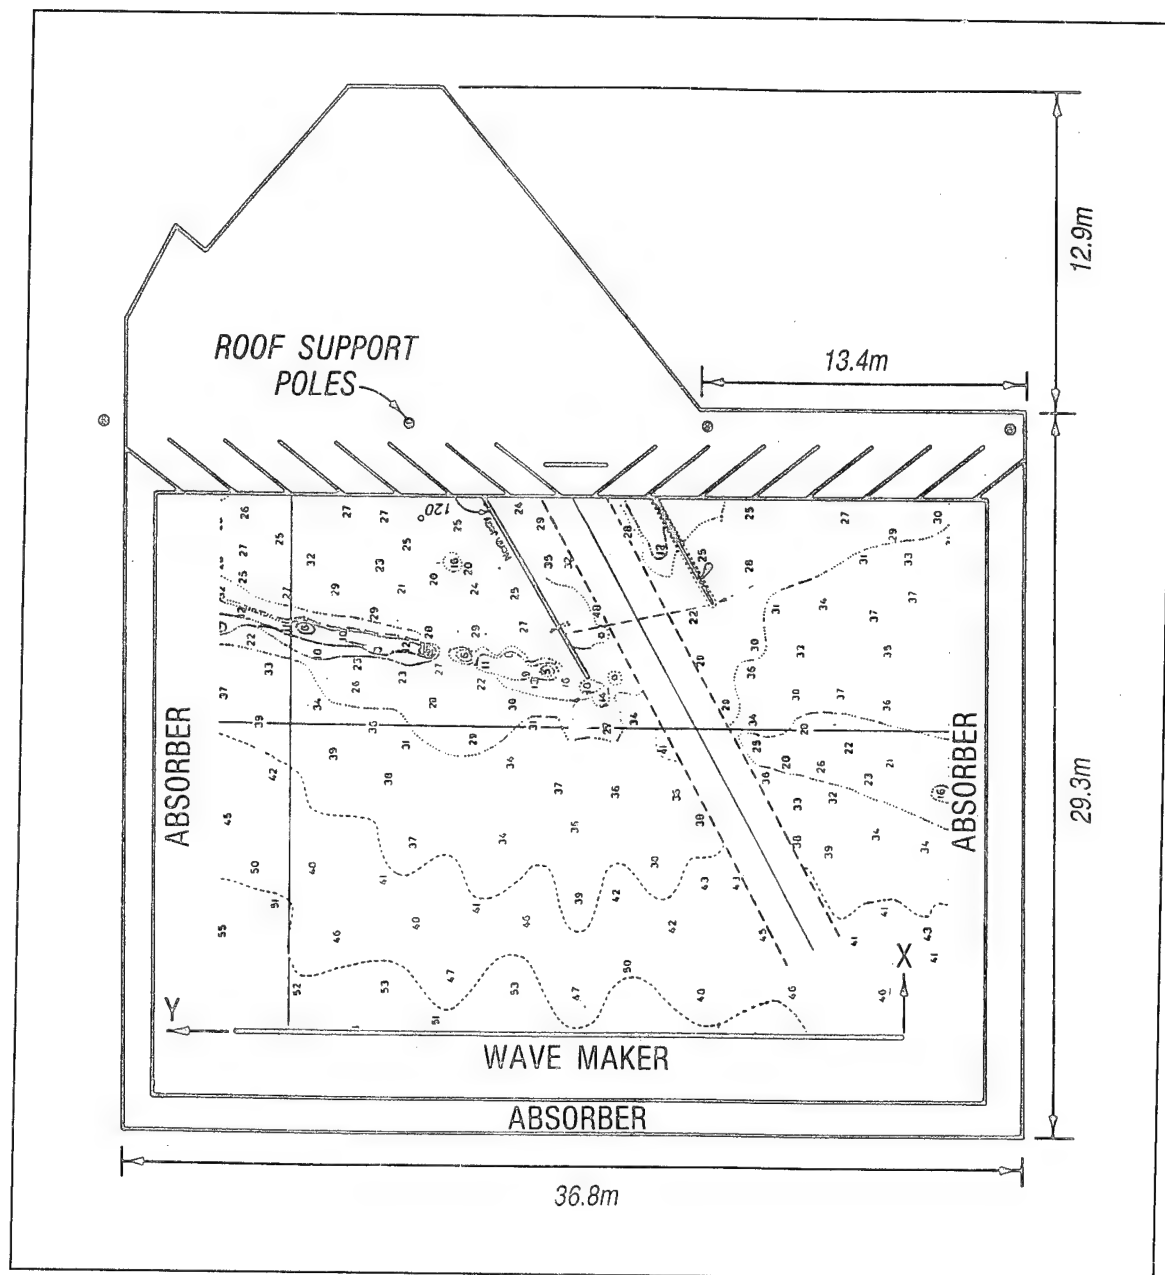
Figure 58. Physical model layout for stability study of 1978 north jetty rehabilitation

The wave board in the basin was located at a depth corresponding to -17.7 m (-58 ft) mllw in the prototype, and the molded bathymetry extending from the wave board to the jetty was intended to provide the same wave transformation in the model that occurs in the prototype. The model plan view is shown in Figure 58. Passive wave absorbers consisting of "horsehair" rubberized mats placed on metal support frames were used to minimize wave reflections by the basin boundaries.

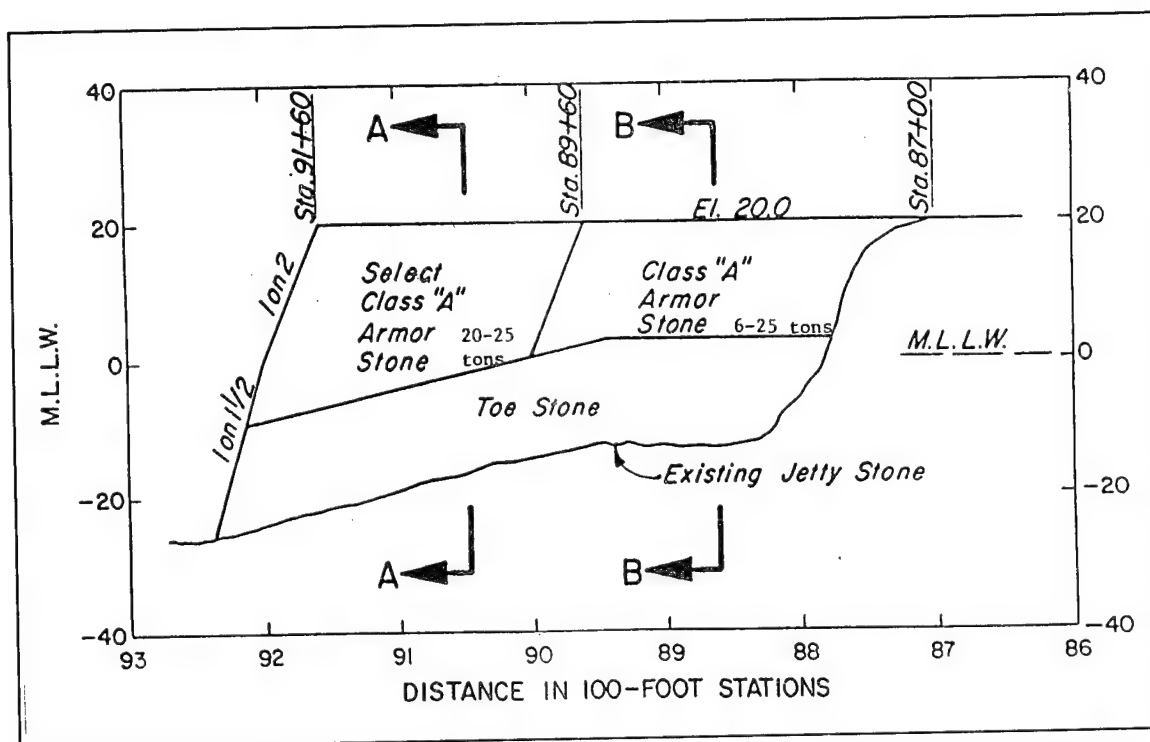
Figure 59. Yaquina Bay north jetty 1978 rehabilitation jetty profile

The north jetty in the model was constructed according to the cross sections as given in Figures 59 and 60. (Note that jetty station numbering differs from the scheme used in the MCCP study.) No information was available on the condition of the bedding layer and remnants of the 1966 construction in

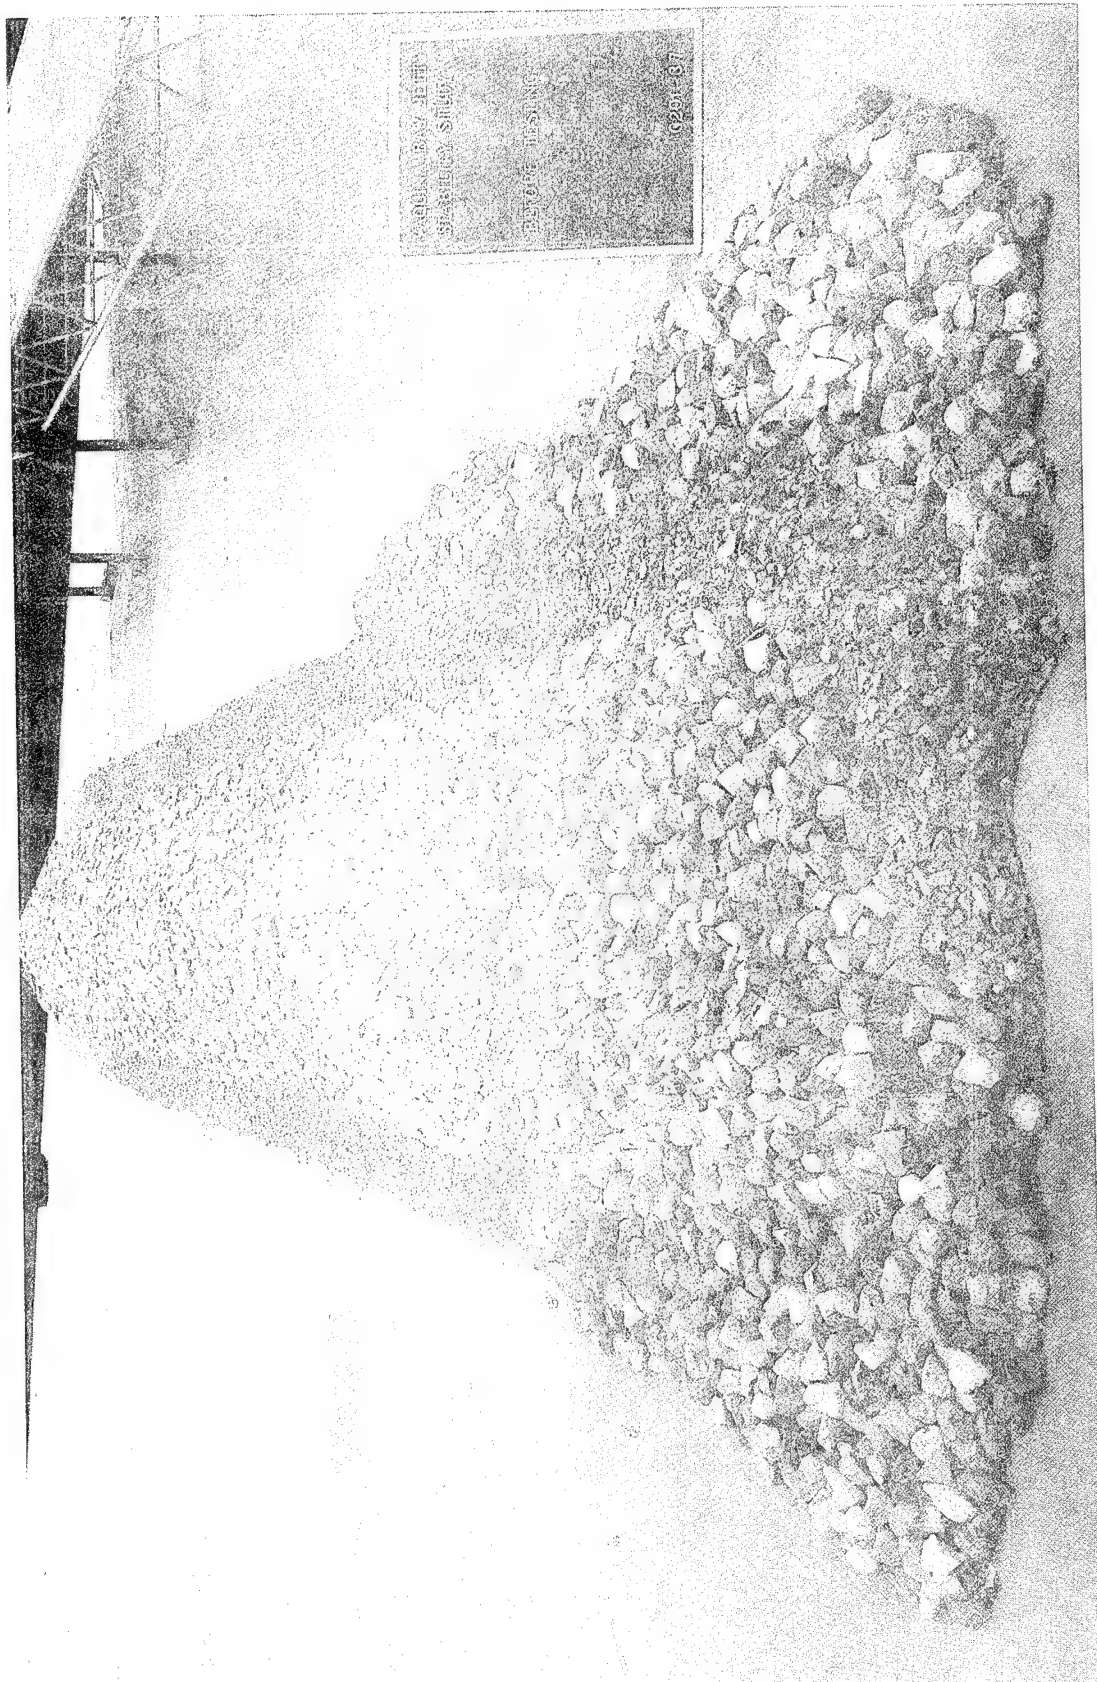
Figure 61. Photograph of model north jetty from stability study of 1978 rehabilitation

the portion of the jetty that had been damaged before the 1978 rehabilitation. Therefore, bedding and core materials were placed in a manner similar to a new construction, but with a wider base. The two layers of select class "A" stone used as the primary armor were specially shaped parallelepiped stones with a maximum length between two and three times the shortest dimension. Scaling for the 1:45 scale model resulted in average select "A" class 18-tonne (20-ton) armor stones in the prototype being represented by model armor stones with a mass of about 0.2 kg (0.44 lb). These model armor stones were handmade to Portland District specifications. Above mllw, stones were placed with their long axis perpendicular to the jetty slope. Below the waterline, stone placement was random. Special placement of the slab-like armor stones results in increased stability compared to randomly placed stone. Figure 61 shows a photograph of the completed north jetty model structure.
